## AIRCRAFT ACCIDENT REPORT

IN-FLIGHT FIRE/EMERGENCY LANDING  
FEDERAL EXPRESS FLIGHT 1406  
DOUGLAS DC-10-10, N68055  
NEWBURGH, NEW YORK  
SEPTEMBER 5, 1996

The National Transportation Safety Board determines that the probable cause of this accident was an in-flight cargo fire of undetermined origin.

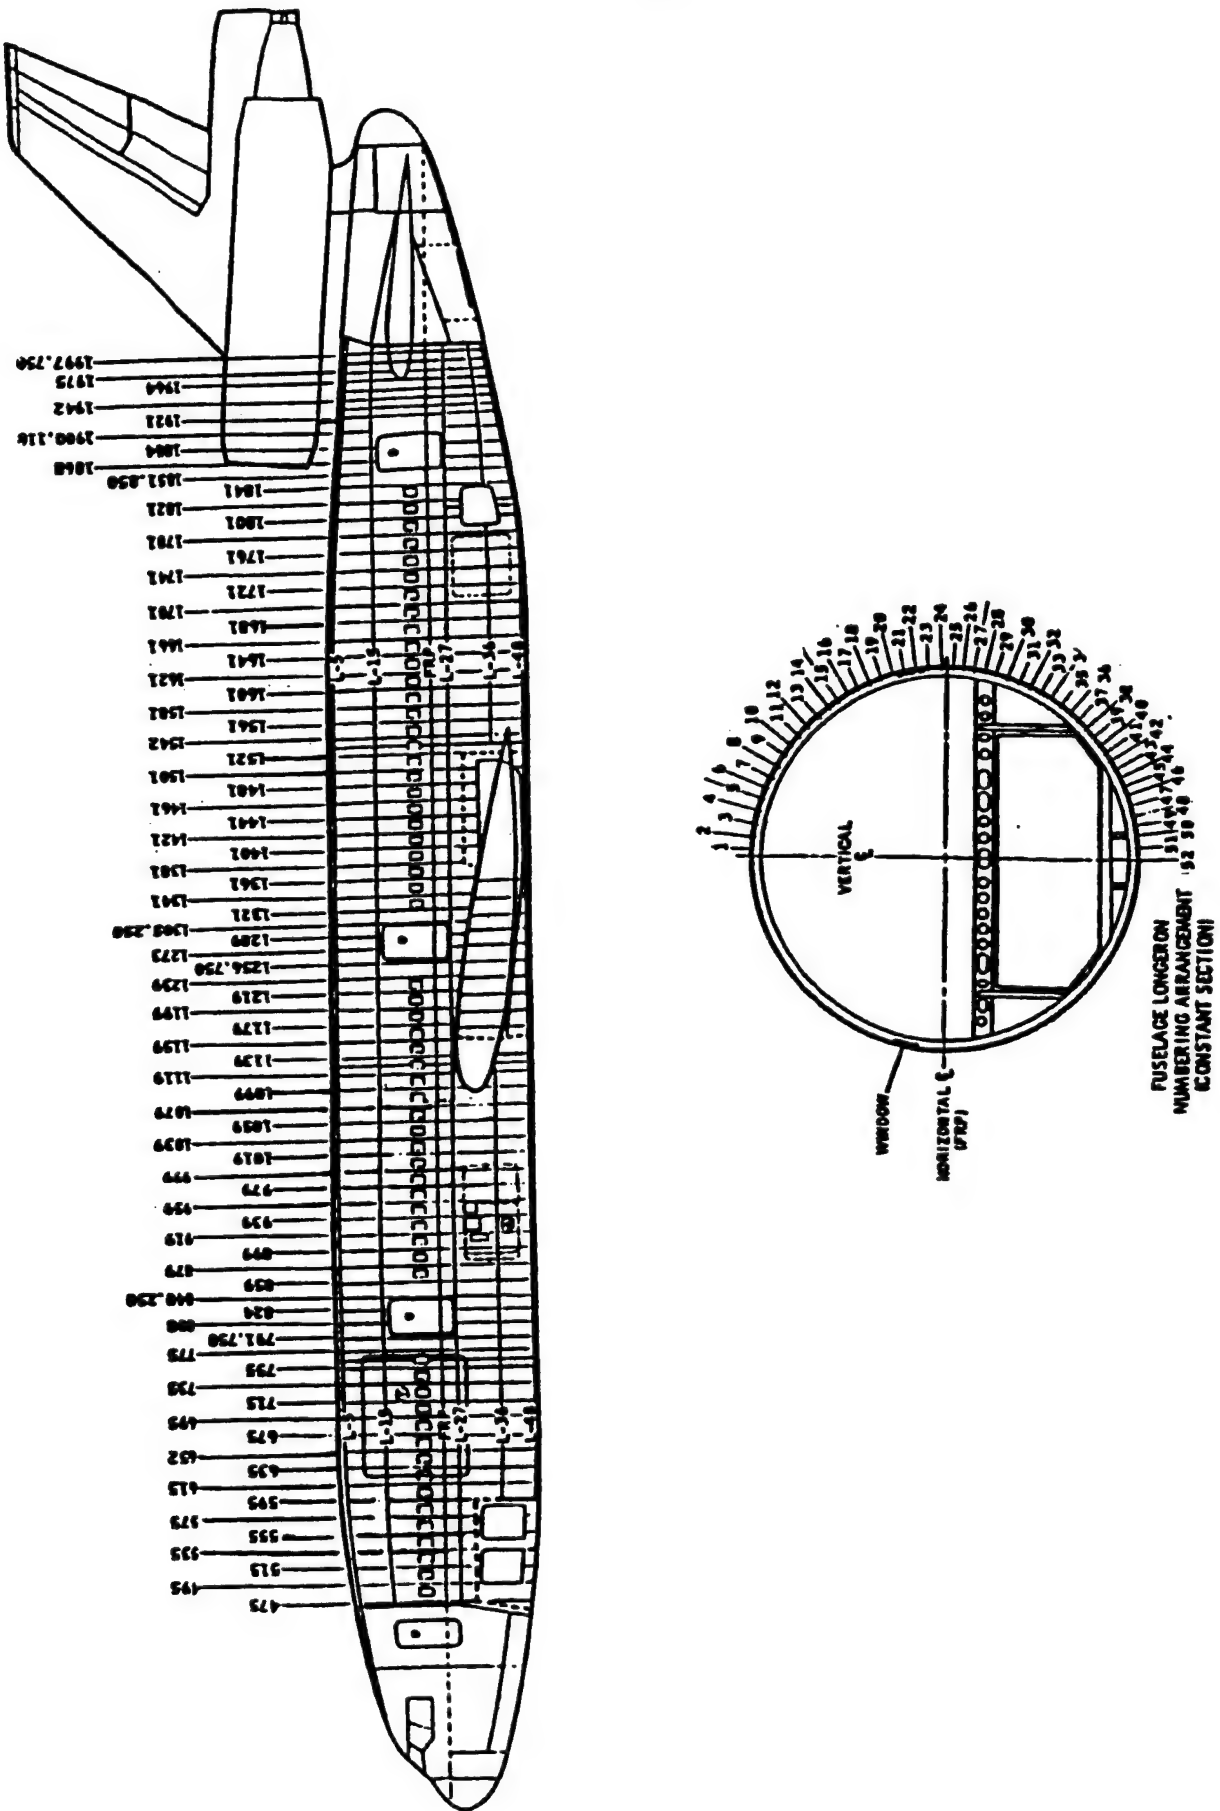
Figure 6.—DC-10-10, N68055, fuselage station and longeron number locations.

At the separated empennage section, the upper interior fuselage crown and the canted area of the aft pressure bulkhead were heavily sooted between longeron 15 left and longeron 23 right. Four of the upper fuselage ring frames were burned and melted between longeron 1 left and the upper canted bulkhead, parallel to longerons 18 left and right. The No. 2 engine bleed air duct was separated about 3 feet forward of the bulkhead. Electrical wires protruded about 20 feet from the aft pressure bulkhead and had cut and separated ends. The wire insulation remained intact on the wires that protruded from the left side of the aft pressure bulkhead, and the wire insulation was burned around the wires that protruded from the right side of the aft pressure bulkhead. No evidence of arcing of airplane wiring was seen. The lower section of the aft pressure bulkhead that was common to the lower cargo area was undamaged and had no soot or fire damage.

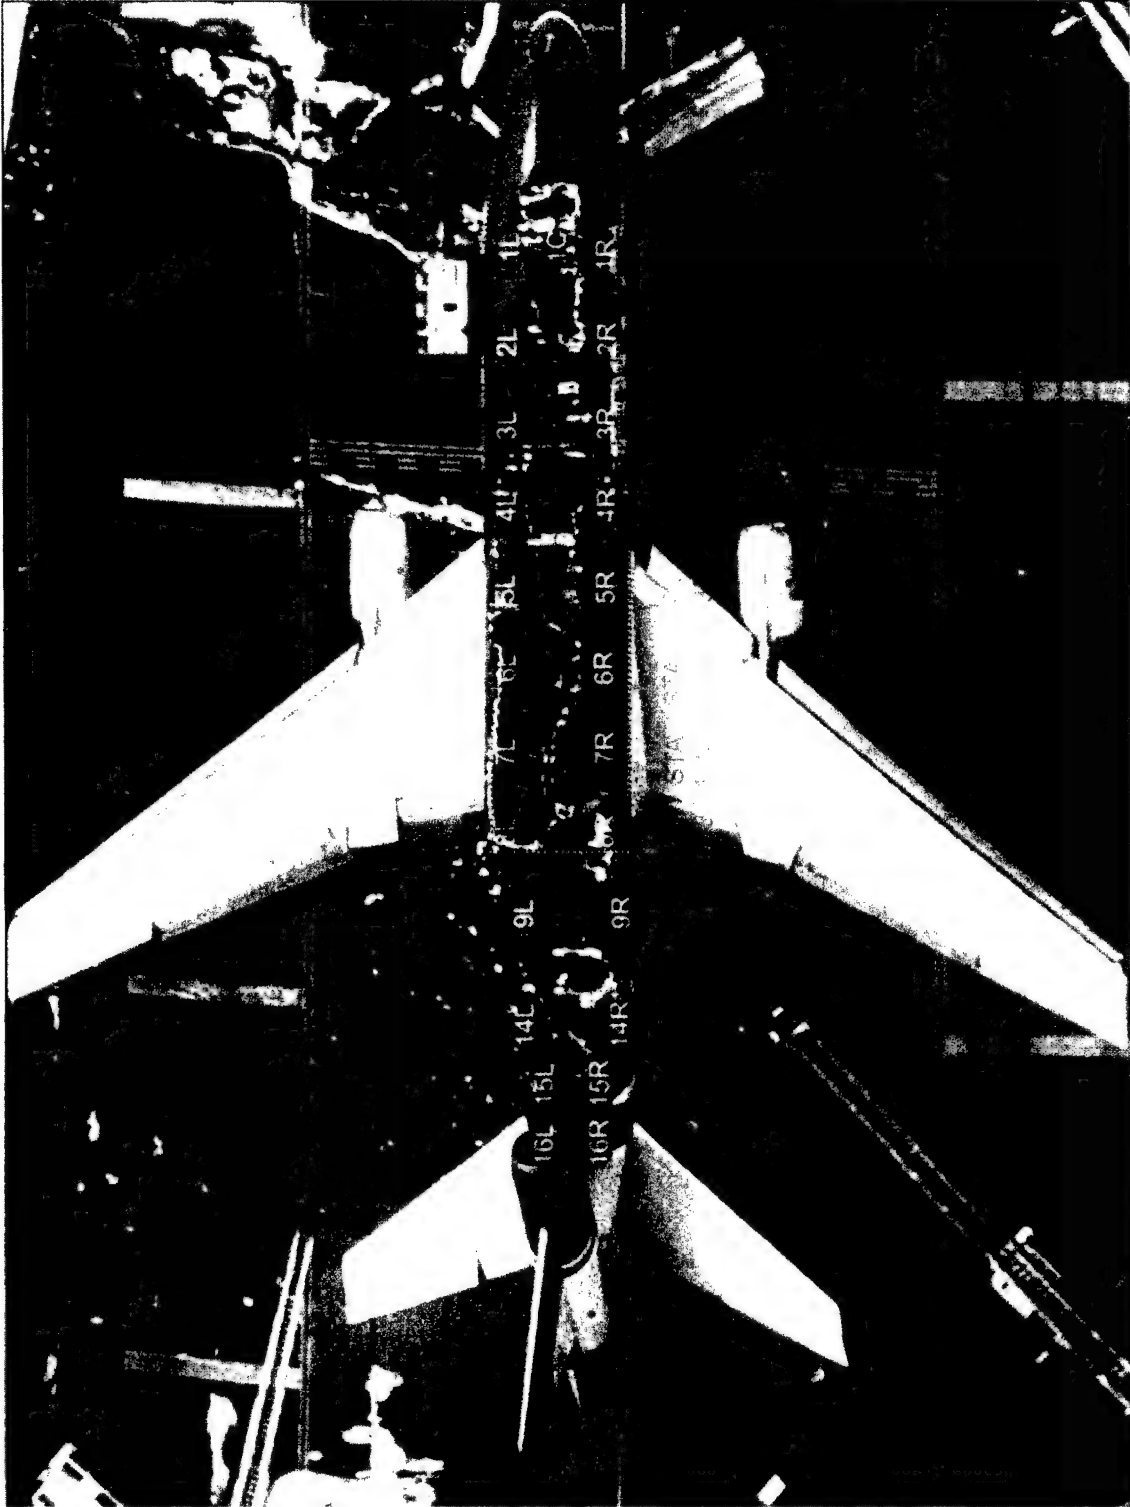
Figure 7.—DC-10-10, N68055, airplane with overlaid cargo container positions.

The cabin sidewall panels were lightly sooted and remained attached to the left side of the fuselage between FS 450 and 840, above container position 3L. Burned and sooted upper sidewall panels hung down directly above the attached lower sidewall panels. The right side of the fuselage between FS 808 and FS 919, next to container position 3R, exhibited severe heat and fire damage, along with melted fuselage frame flanges. The airplane's exterior paint was scorched and bubbled on the left side, next to the first two windows between FS 859 and 899, near the aft of container row 3 and the front of container row 4.

The fuselage crown was consumed by the fire between FS 939 and FS 1039, from approximately the middle of container row 4 to the middle of container row 5. The frame flanges on either side of this consumed area of the fuselage crown were burned and melted. The left side of the fuselage crown was also consumed by fire between FS 1179 and FS 1531, an area corresponding to approximately the middle of cargo container 6L to the middle of cargo container 9L.

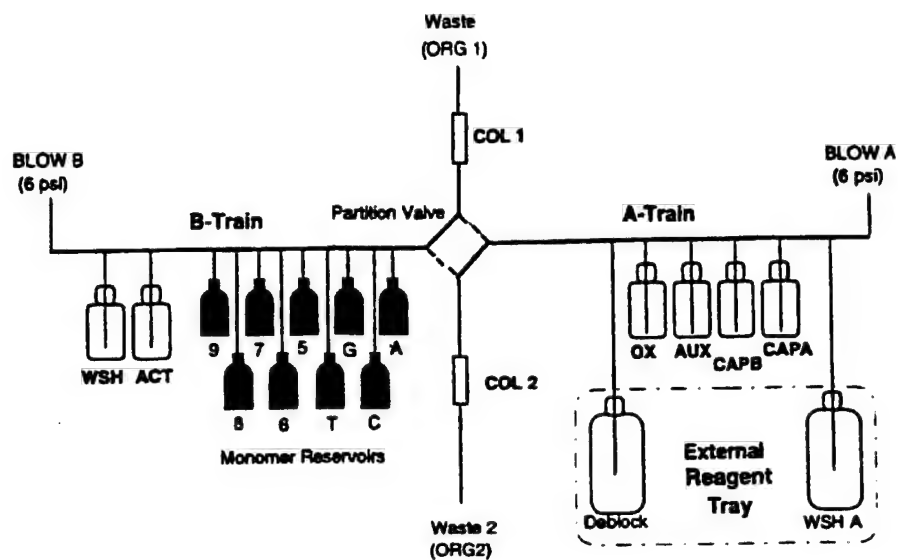
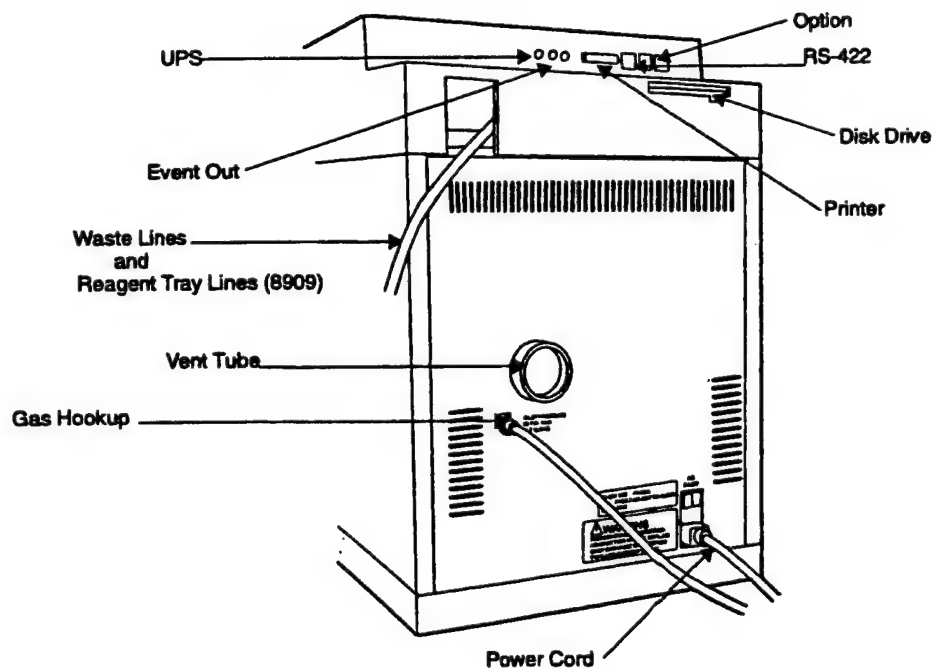
Figure A.—Expedite Model 8909 DNA synthesizer instrument diagram.

A paper diagram of the bottle locations and system schematic taped inside the front door of the synthesizer exhibited slight soot damage. The paint on the inside of the door below the window frame was undamaged but exhibited some sooting. The inside of the door exhibited heavier heat damage above the lower window frame than was observed below the window frame. The stainless steel bottle bracket was heavily sooted behind bottles 4, 5, and 6. The plastic dip tubes were cut off during the on-site accident phase. The upper third of the right side of the stainless steel bottle bracket exhibited some sooting and discoloration. The left side was sooted from the base to the top of the synthesizer. The polyethylene drip tray was melted along the right rear side and was heavily sooted along the left and forward walls. An 8½- by 9½- inch rectangular soot-free area was observed approximately 1 inch from the left side of the drip tray. Pieces of broken glass and a large amount of debris were found in the bottom of the drip tray. The floor of the synthesizer was heavily sooted and also contained pieces of debris. There was some blue discoloration along the right side of the stainless steel bracket where it intersected the mounting for bottles 1, 2, and 3.

Removal of the synthesizer controller top revealed that the controller top's interior exhibited extensive fire damage, and all of the electrical wire insulation was destroyed. The wire conductors were intact and brittle. The inside of the top was heavily sooted. Most of the paint was charred and missing under the controller PC board and around the floppy drive at the rear of the controller top. The resin binder for the controller PC board was destroyed by fire. The
